Project Name: Cavanaugh & Cumberland HVAC

This Addendum is issued to inform the bidders of modifications in the scope of work being bid for this project.

## Limited-Scope NESHAP Asbestos Inspection

## Comprehensive NESHAP Asbestos Inspection

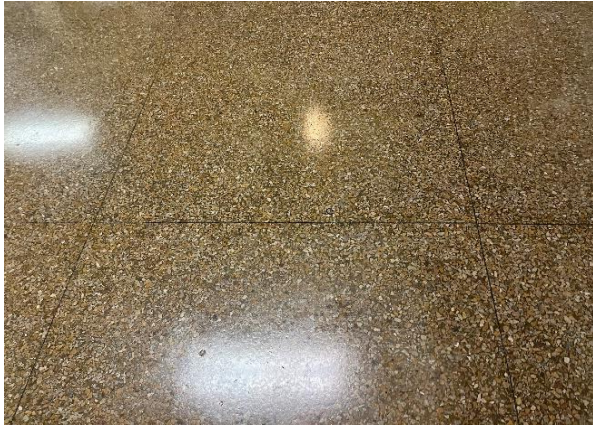
**PHOTOGRAPH # 31**

**HA# 31****MATERIAL DESCRIPTION:**

Flooring - Terrazzo

5,375 s.f.

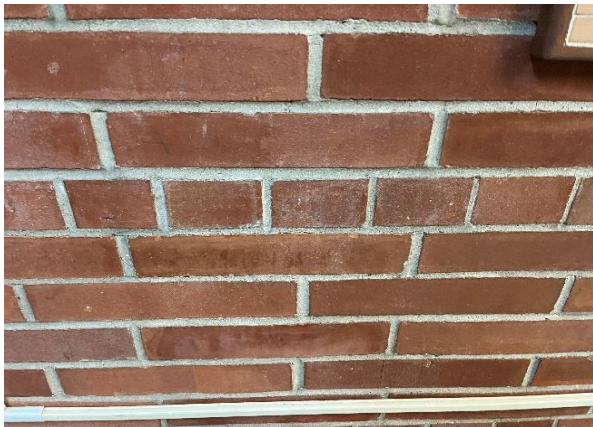
**ADDITIONAL NOTES:****PHOTOGRAPH # 32**

**HA# 32****MATERIAL DESCRIPTION:**

Brick w/ Mortar - Red

16,800 s.f.

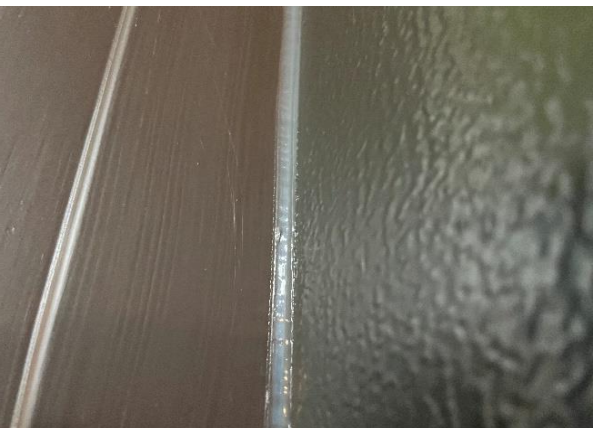
**ADDITIONAL NOTES:****PHOTOGRAPH # 33**

**HA# 33****MATERIAL DESCRIPTION:**

Caulk - Interior - Silicone - Clear
