Project Name: Cavanaugh & Cumberland HVAC

This Addendum is issued to inform the bidders of modifications in the scope of work being bid for this project.

## Limited-Scope NESHAP Asbestos Inspection

## Comprehensive NESHAP Asbestos Inspection

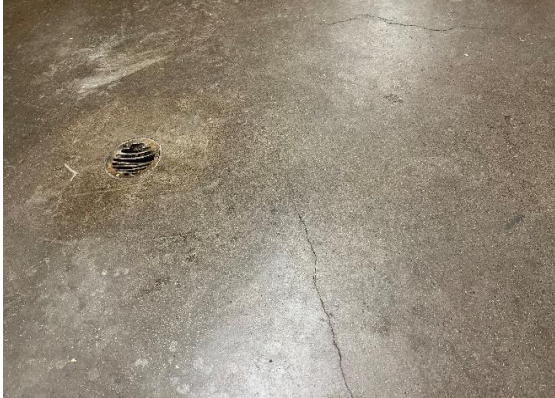
**PHOTOGRAPH # 1**

**HA# 1****MATERIAL DESCRIPTION:**

Concrete - Floor

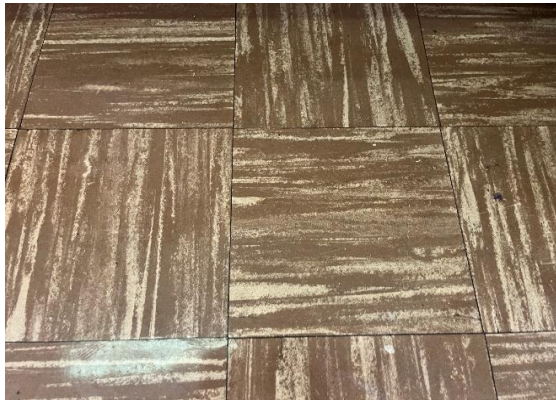
**ADDITIONAL NOTES:****PHOTOGRAPH # 2**

**HA# 2****MATERIAL DESCRIPTION:**

Floor Tile w/ Mastic - 9" - Brown w/ Tan Stripes

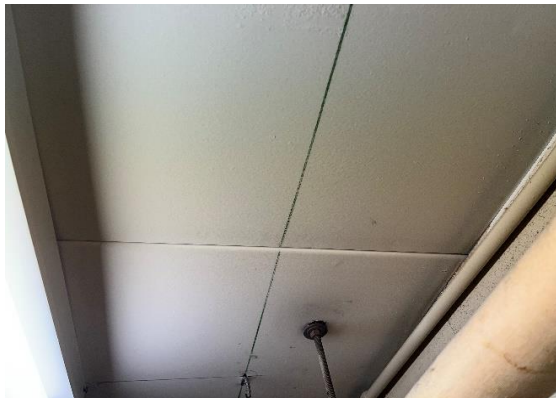
**ADDITIONAL NOTES:****PHOTOGRAPH # 3**

**HA# 3****MATERIAL DESCRIPTION:**

Deck Panels - Metal

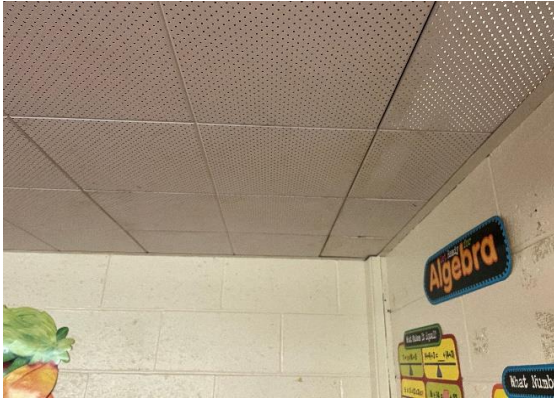
### PHOTOGRAPH # 4

**HA# 4**

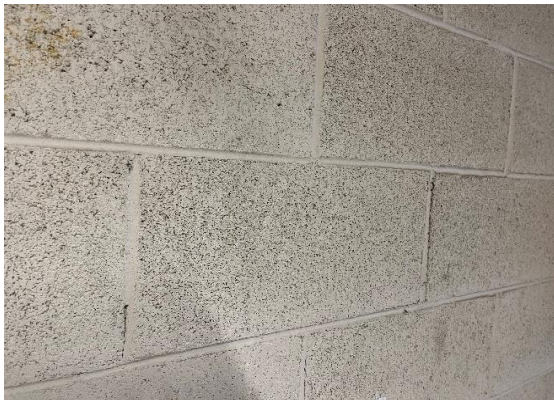
### PHOTOGRAPH # 5

**HA# 5**

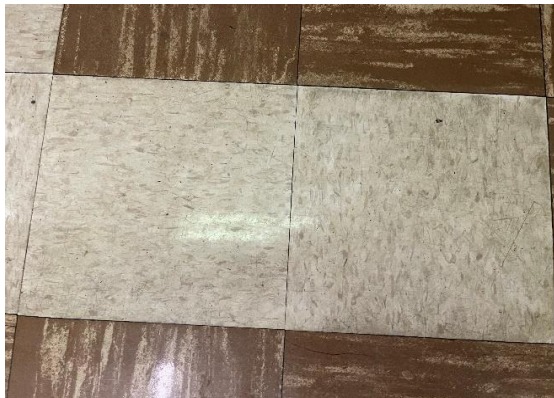
### PHOTOGRAPH # 6

**HA# 6**

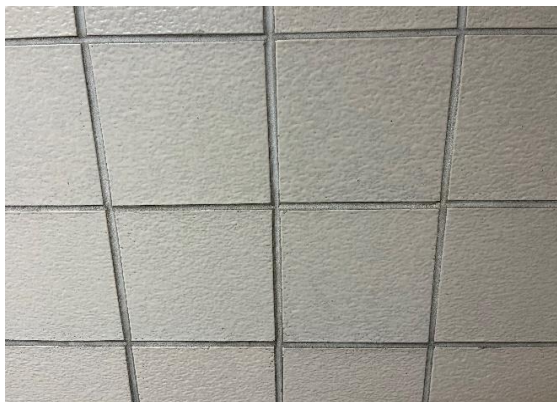
### PHOTOGRAPH # 7

**HA# 7**

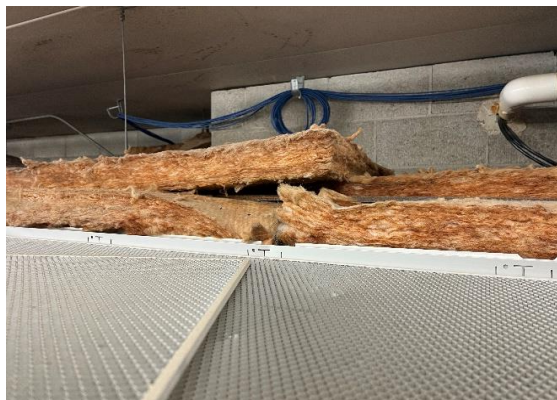
### PHOTOGRAPH # 8

**HA# 8**

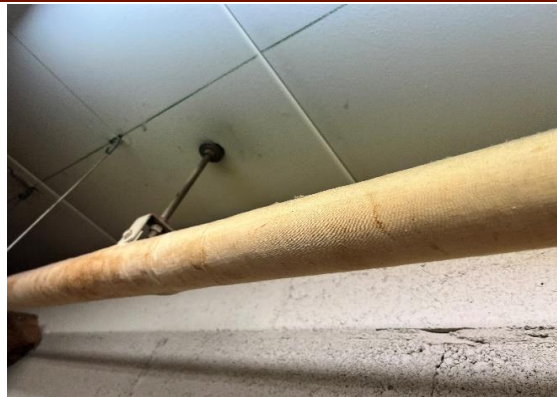
### PHOTOGRAPH # 9

**HA# 9**

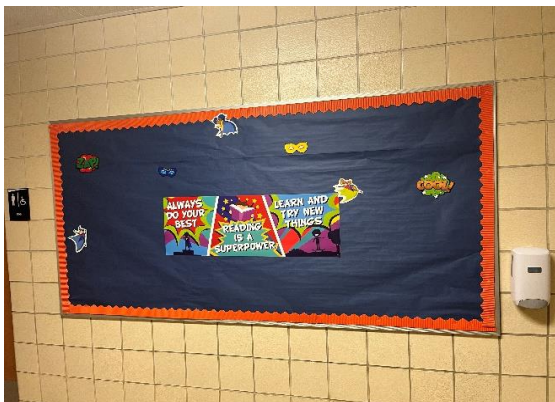
### PHOTOGRAPH # 10

**HA# 10**

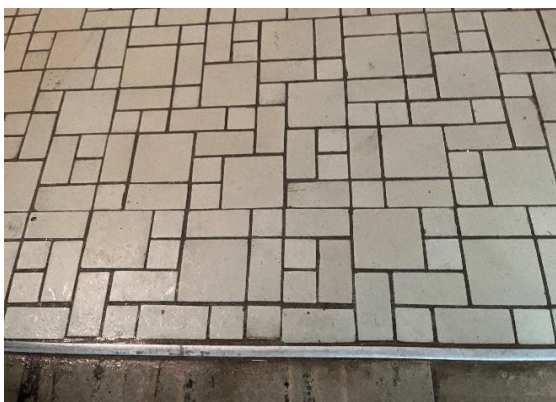
### PHOTOGRAPH # 11

**HA# 11**

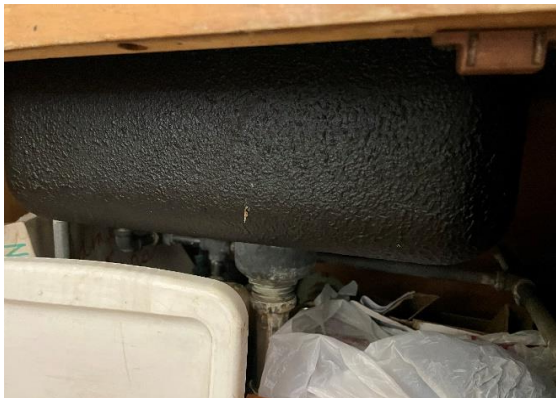
### PHOTOGRAPH # 12

**HA# 12**

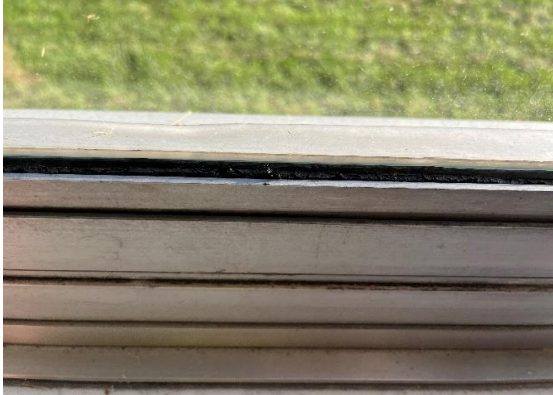
### PHOTOGRAPH # 13

**HA# 13**

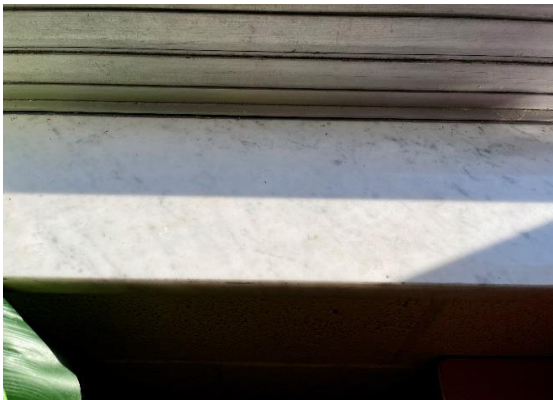
### PHOTOGRAPH # 14

**HA# 14**

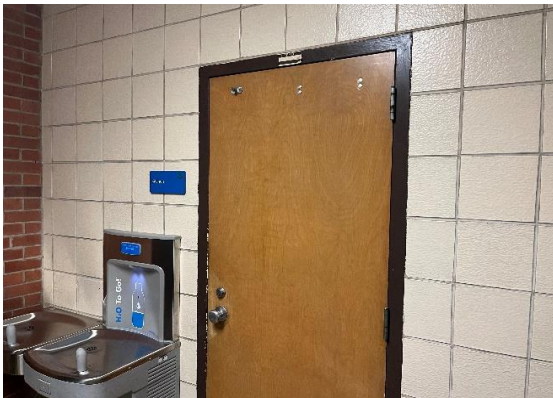
### PHOTOGRAPH # 15

**HA# 15**

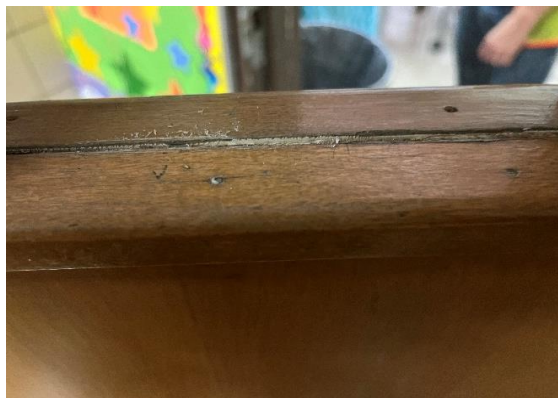
### PHOTOGRAPH # 16

**HA# 16**

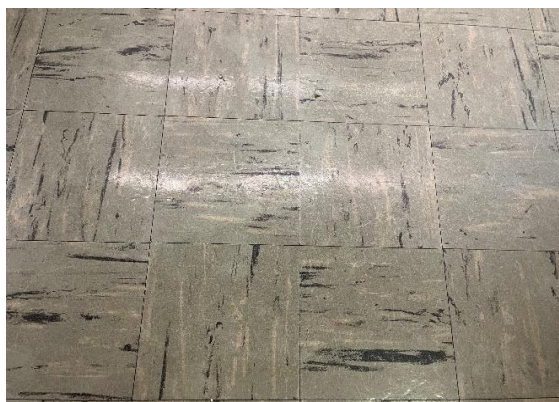
### PHOTOGRAPH # 17

**HA# 17**

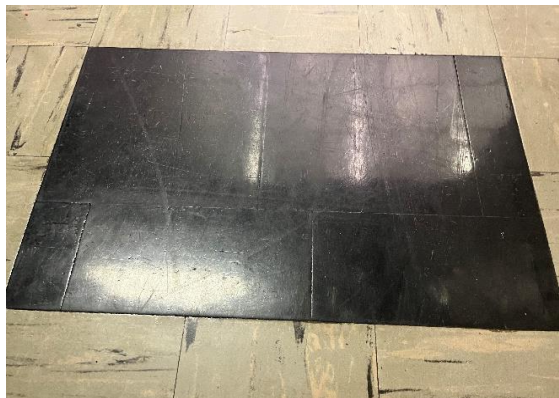
### PHOTOGRAPH # 18

**HA# 18**

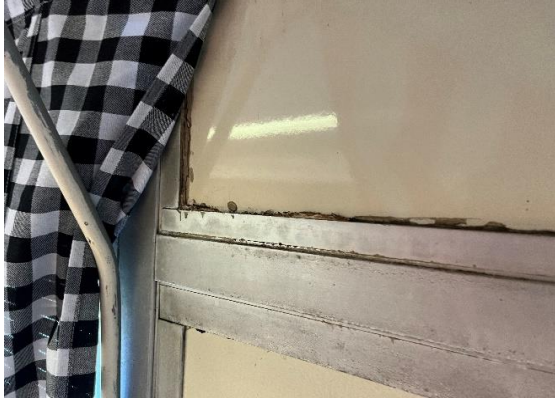
### PHOTOGRAPH # 19

**HA# 19**

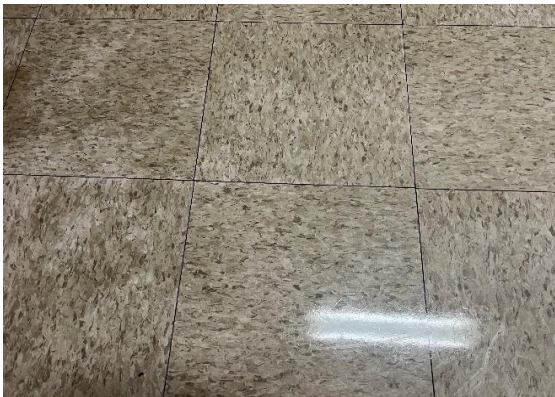
### PHOTOGRAPH # 21

**HA# 21**

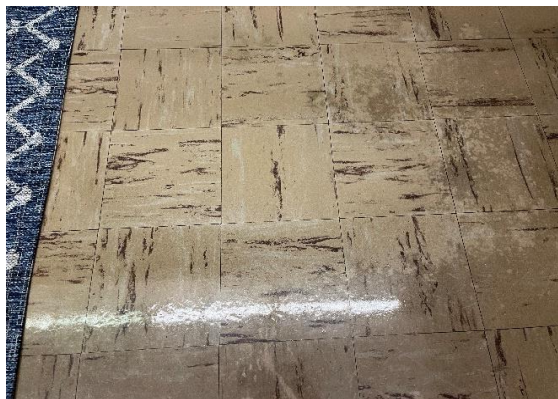
### PHOTOGRAPH # 22

**HA# 22**

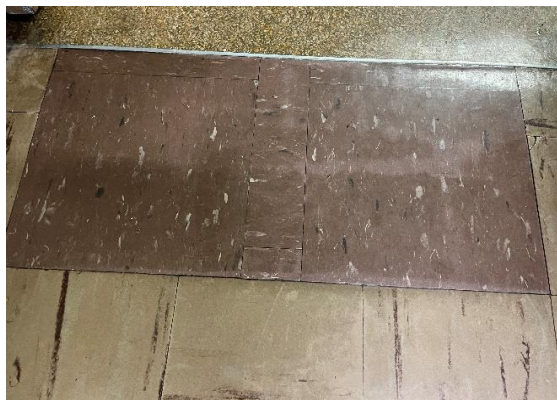
### PHOTOGRAPH # 23

**HA# 23**

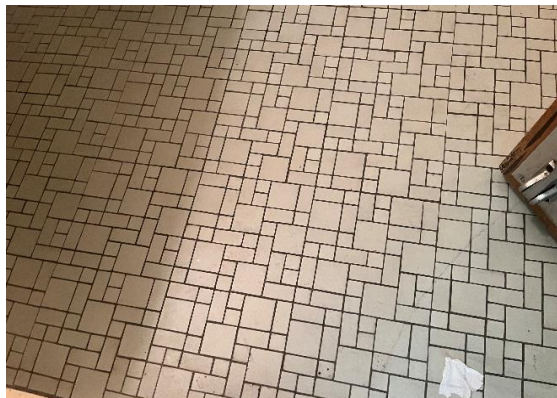
### PHOTOGRAPH # 24

**HA# 24**

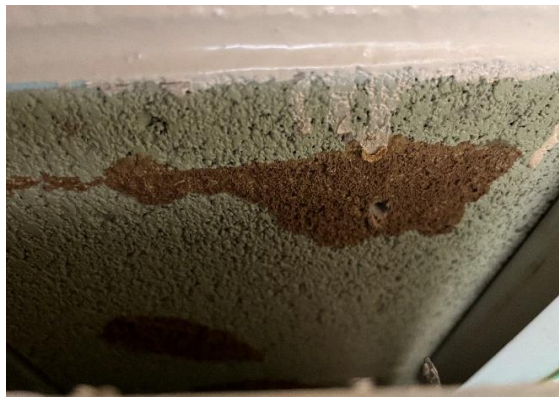
### PHOTOGRAPH # 25

**HA# 25**

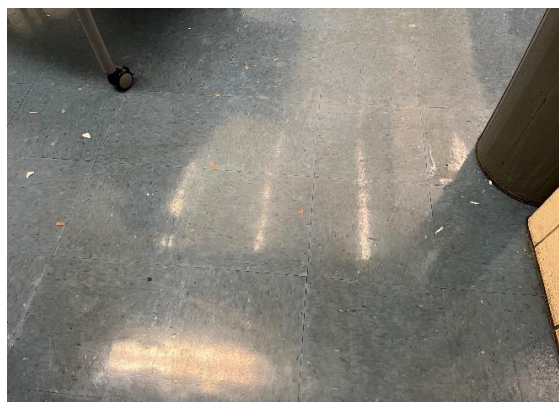
### PHOTOGRAPH # 26

**HA# 26**

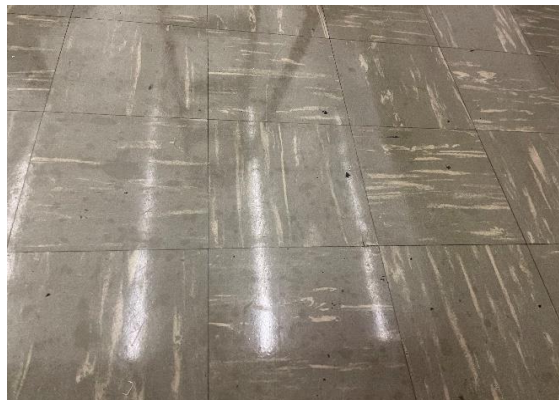
### PHOTOGRAPH # 27

**HA# 27**

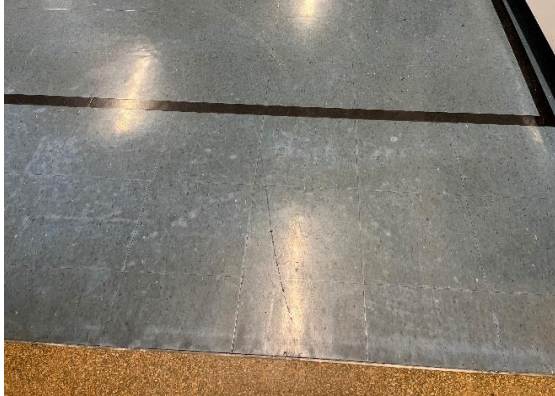
### PHOTOGRAPH # 28

**HA# 28**

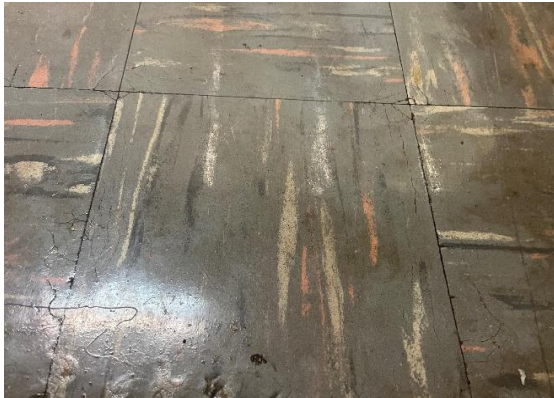
### PHOTOGRAPH # 29

**HA# 29**

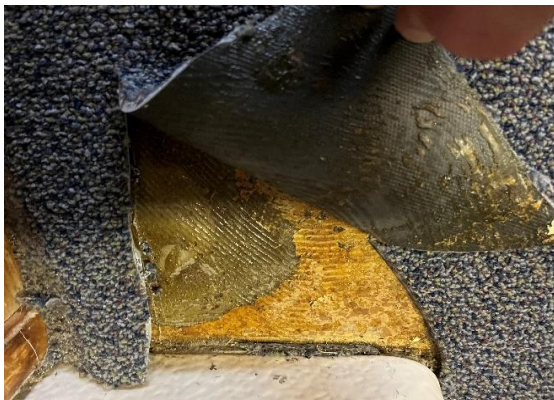
### PHOTOGRAPH # 30

**HA# 30**

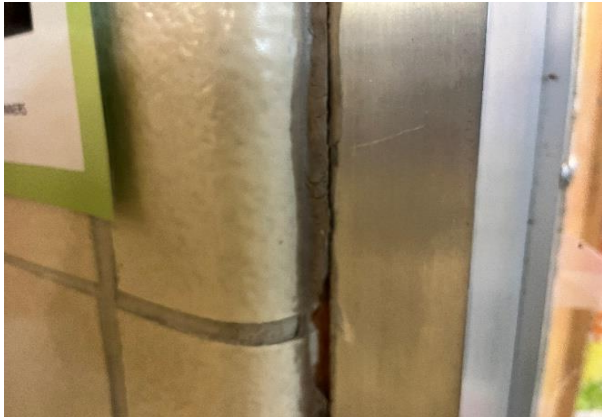
**PHOTOGRAPH # 34**

34	Caulk - Interior - Gray - Brittle	2% Chrysotile	1 sq. ft.
38	Floor Tile w/ Mastic - 9" – Tan	Yellow Mastic = Not Detected Gray Float = Not Detected Floor Tile = 5% Chrysotile Mastic = Not Detected	924 sq. ft.
42	Glazing - Interior Window - White - Powdery	2% Chrysotile	22 sq. ft.
44	Floor Tile w/ Mastic - 9" - Orange Brown Mottled	Floor Tile = 5% Chrysotile Mastic = Not Detected	160 sq. ft.
47	Floor Tile w/ Mastic - 9" - Dk Brown w/ Confetti Speckles	Floor Tile = 5% Chrysotile Mastic = Not Detected	525 sq. ft.
51	Floor Tile w/ Mastic - 9" - Tan w/ Confetti Speckles	Floor Tile = 5% Chrysotile Mastic = Not Detected	2,560 sq. ft.

**HA# 34****MATERIAL DESCRIPTION:**

Caulk - Interior - Gray - Brittle

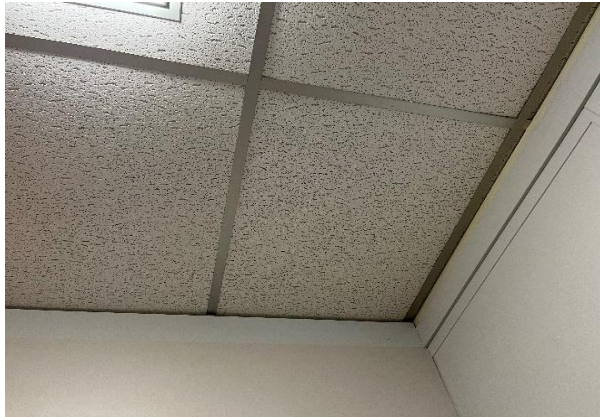
### PHOTOGRAPH # 37

**HA# 37**

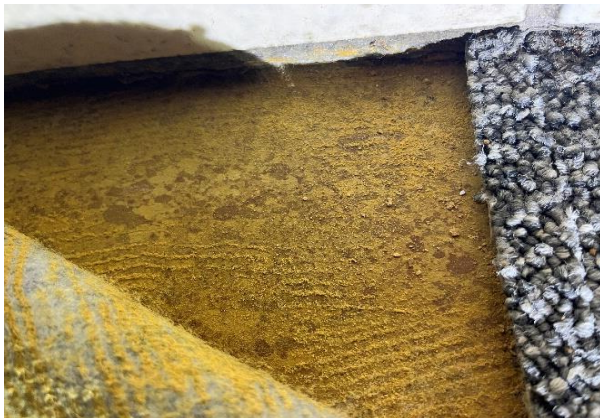
### PHOTOGRAPH # 38

**HA# 38**

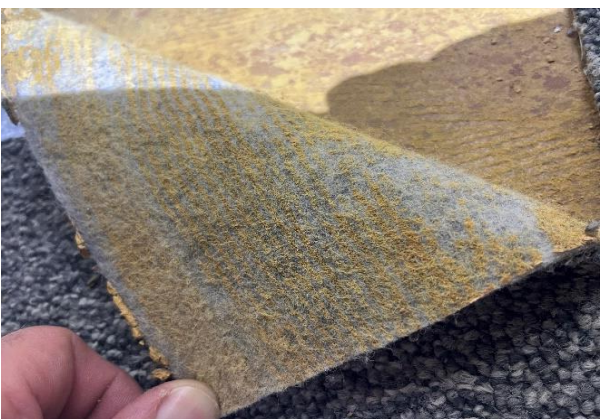
### PHOTOGRAPH # 39

**HA# 39**

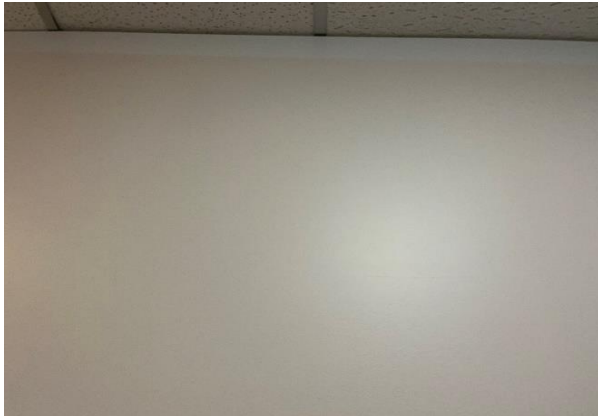
**PHOTOGRAPH # 40**

**HA# 40****MATERIAL DESCRIPTION:**

Drywall - Wall

230 s.f.

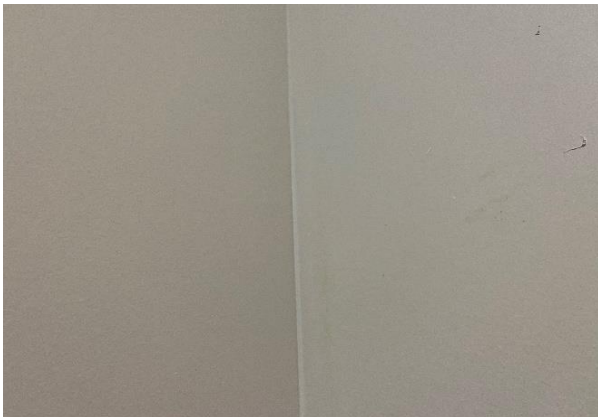
**HA# 41****MATERIAL DESCRIPTION:**

Joint Compound - Associated w/ Drywall - Wall

230 s.f.

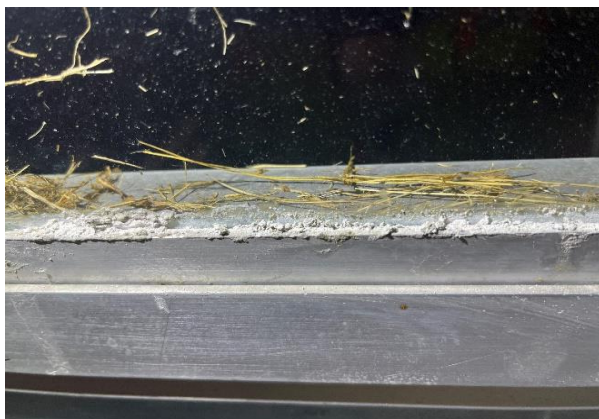
**HA# 42****MATERIAL DESCRIPTION:**

Glazing - Interior Window - White - Powdery

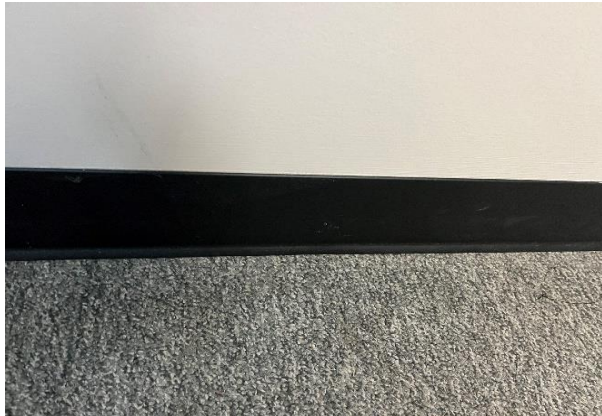
### PHOTOGRAPH # 43

**HA# 43**

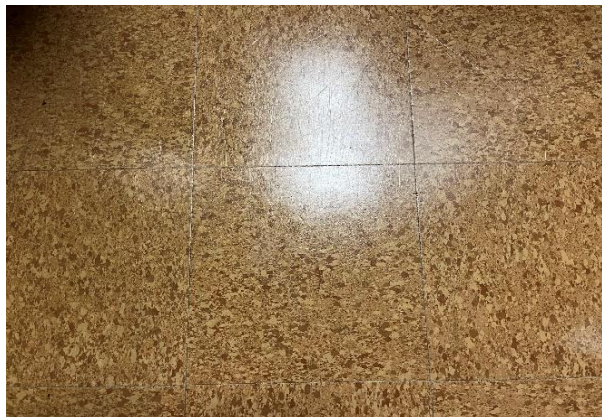
### PHOTOGRAPH # 44

**HA# 44**

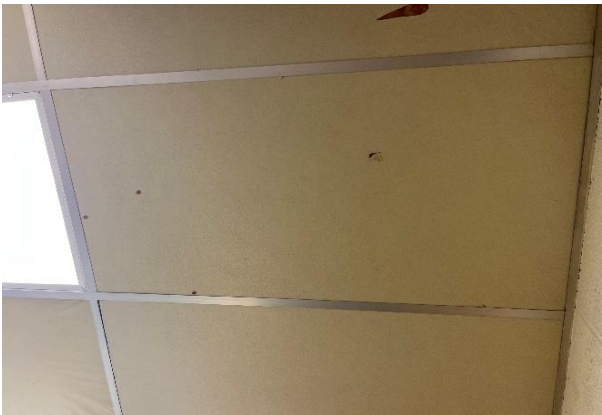
### PHOTOGRAPH # 45

**HA# 45**

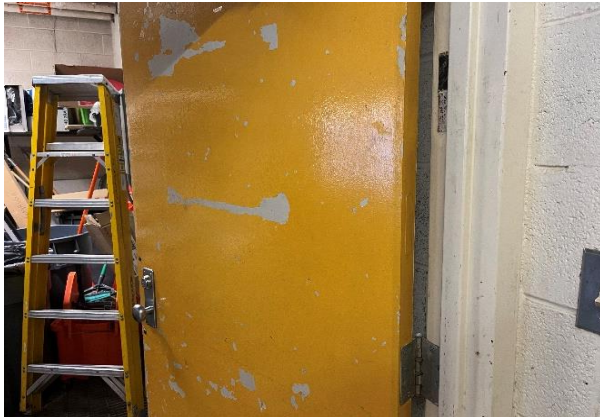
### PHOTOGRAPH # 46

**HA# 46**

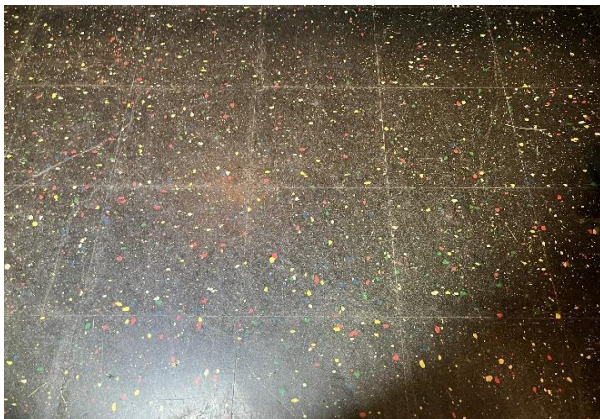
### PHOTOGRAPH # 47

**HA# 47**

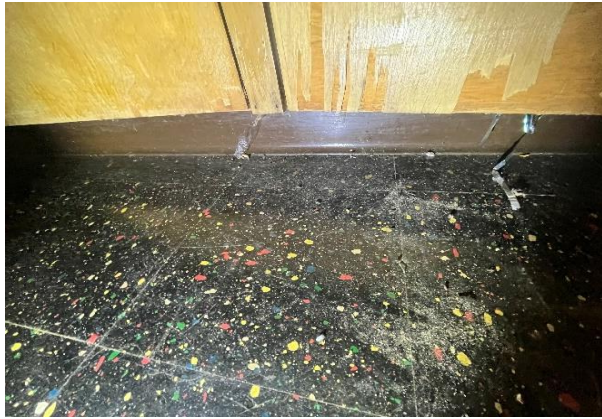
### PHOTOGRAPH # 49

**HA# 49**

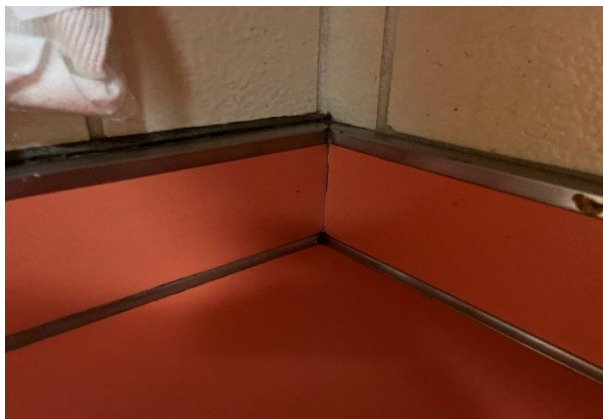
### PHOTOGRAPH # 52

**HA# 52**

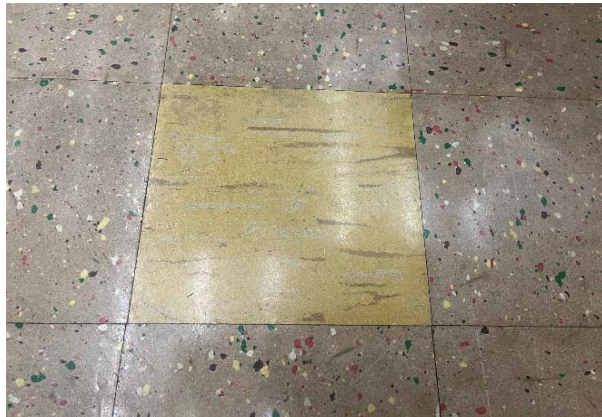
### PHOTOGRAPH # 55

**HA# 55**

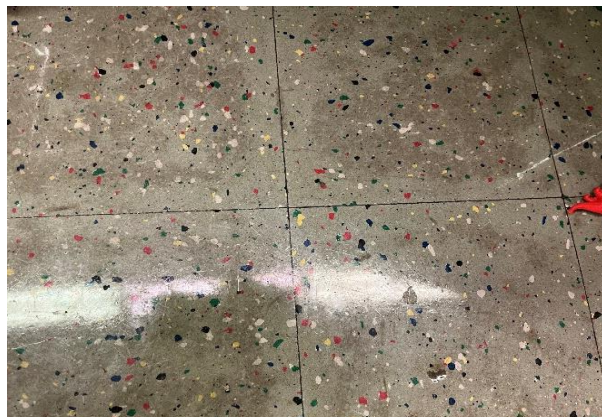
### PHOTOGRAPH # 56

**HA# 56**

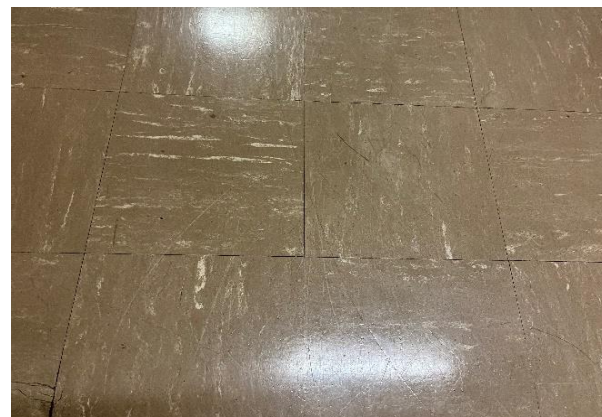
### PHOTOGRAPH # 57

**HA# 57**

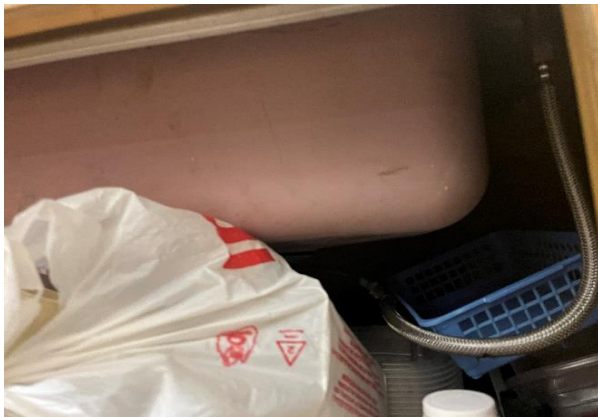
### PHOTOGRAPH # 59

**HA# 59**

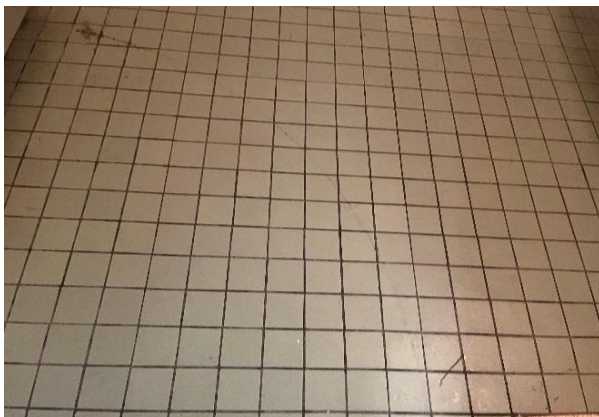
### PHOTOGRAPH # 60

**HA# 60**

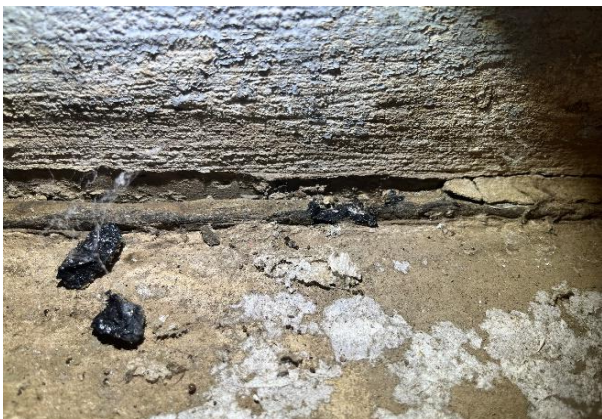
### PHOTOGRAPH # 75

**HA# 75**

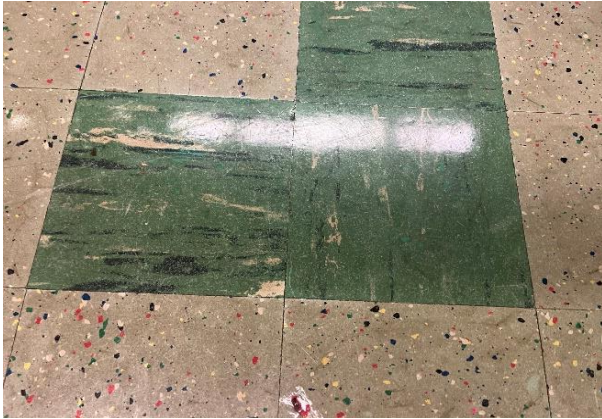
### PHOTOGRAPH # 76

**HA# 76**

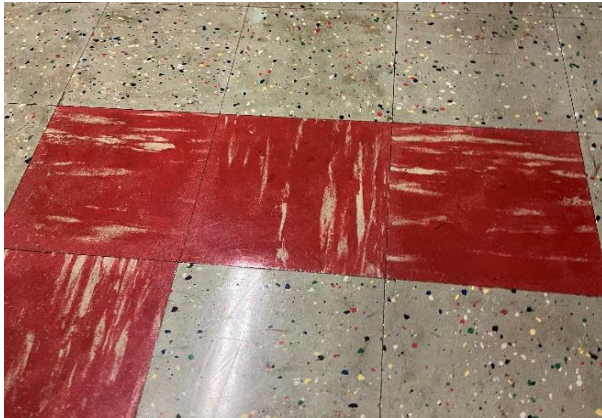
### PHOTOGRAPH # 77

**HA# 77**
